Kiely Arborist Services LLC

March 15th, 2021, Revised July 19th, 2021

Site: 355 1st St, 365 1st St, 371 1st St, and 373 1st St, Los Altos

As requested on Wednesday, March 10th, 2021, I visited the above site for the purpose of inspecting and commenting on the trees. Development is proposed for this site consisting of condos and underground parking, and as required by the City of Los Altos, a survey of the trees and a tree protection plan will be provided within this report. The entire 41 page building permit plan set (second submittal) dated 7/16/21 was reviewed for writing this report. This report will go over the existing health of the protected trees and will give recommendations for construction as needed followed by a tree protection plan.

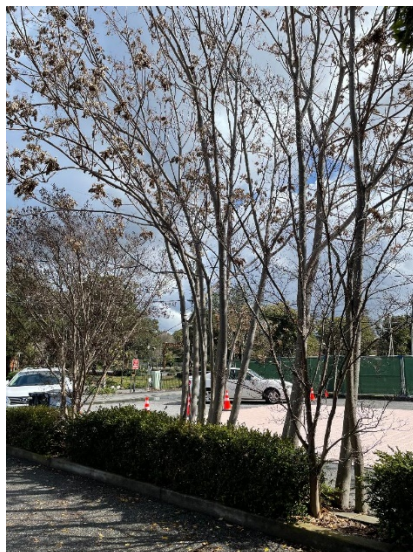
The existing landscape is in fair condition. Many trees surround the site. All of the trees are surrounded by hardscapes or building foundations. Damages to the hardscapes were observed near all of the trees on site. Ailanthus (tree of heaven) trees were found on site. This species is highly invasive and recommended for removal.

Showing tree of heaven trees #23-25

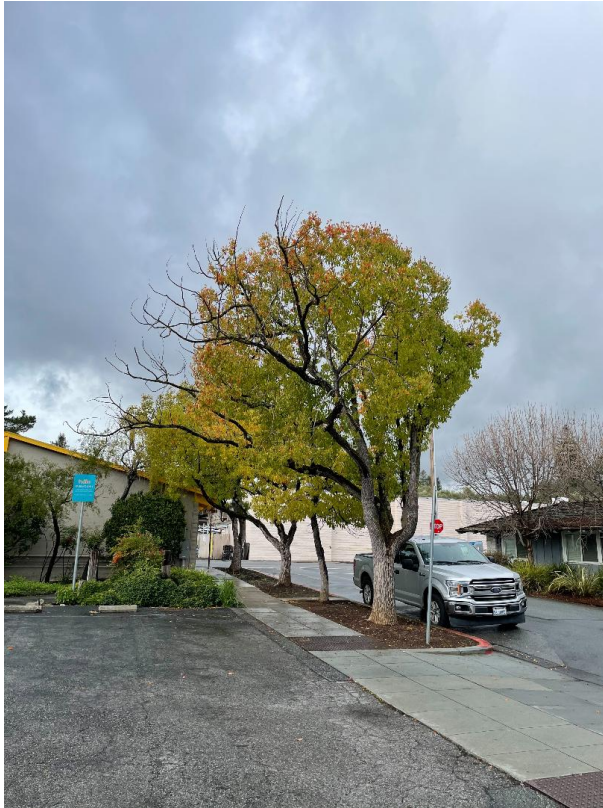
Camphor street trees #1-6 are in fair condition except for camphor tree #3. The trees are within a planting strip between the sidewalk and street. The sidewalk and curb have been damaged by the tree roots in the past. Camphor trees are one of the species widely known for causing damage to hardscapes as they tend to develop large surface roots. Areas of dead wood were observed in the canopies. Camphor tree #3 is in poor condition due to being topped in the past.

Showing camphor street trees with dead wood observed.

Neighboring magnolia trees #31-37, pear trees #38 and #39, and Brisbane box tree #40 are to be retained. These trees will be protected by tree protection fencing located at the property line. Camphor street trees #1-6 are to be retained. These trees will require tree protection fencing. It is recommended to fence off the entire street tree planting strips. Basement excavation is recommended to be inspected by the Project Arborist when near these trees. Exposed roots due to the excavation of the basement will need to be cleanly cut back to the basement wall. While cut root ends are exposed, the exposed roots are recommended to be covered by 3 layers of wetted down burlap. Burlap moisture will need to be retained by spraying down the burlap multiple times a day. The camphor trees are recommended to be deep water fertilized anytime between fall and early spring time. The retained camphor street trees will need to be irrigated every 2 weeks during the dry season. Soaker hoses on a timer are recommended to be installed within the street tree planting strips. Irrigation is recommended to saturate

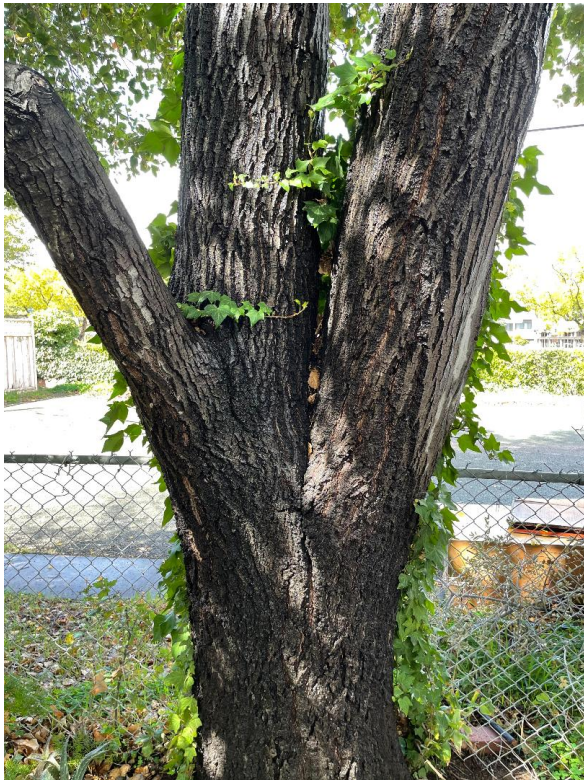
Oak tree #15 is in fair condition. The tree has poor form with codominant stems at 4 feet. The codominant leaders have formed included bark within the union. Included bark can significantly raise the risk of a leader failure. The tree is completely covered by hardscapes.

Showing included bark at 4 feet

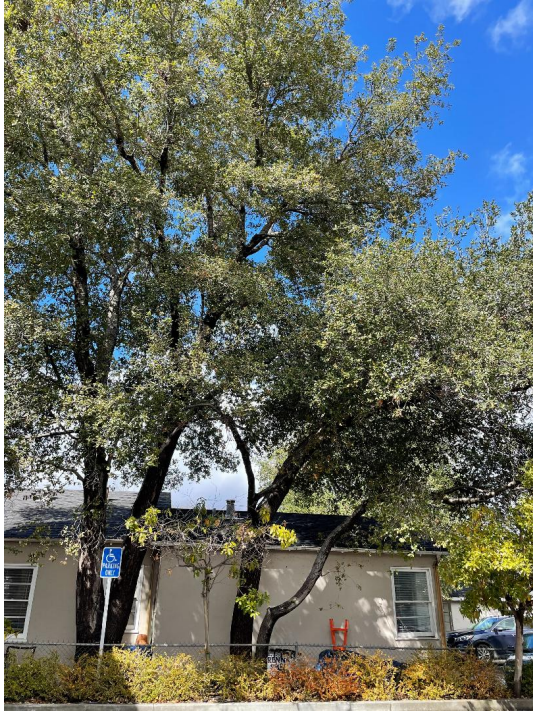
Oak trees #16-19 are located between 2 parking areas at 371 and 373 first street. Oaks #18, and #19 are of a protected size. The trees are in fair to good condition except oak tree #16 in poor condition. The property at 371 and 373 are at different grades. The lot at 371 where the trunks of the oaks are located is lower than the property at 373 first street. Demolition would likely have a high impact on these trees, also the trees would take up a large area of available space if retained. Oak trees #18 and #19 are within a few feet from the existing foundation.

Showing oak trees #18 and #19

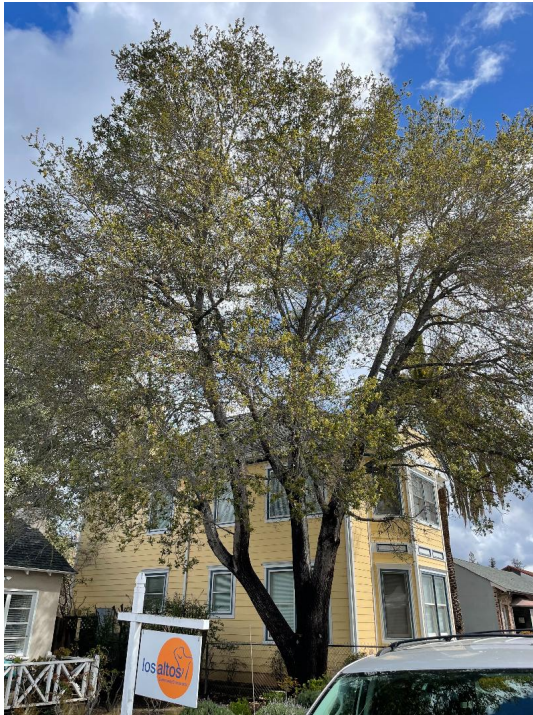
Oak tree #29 is located in front of the property and is in good condition. This is the largest oak tree on the property.

Showing oak tree #29

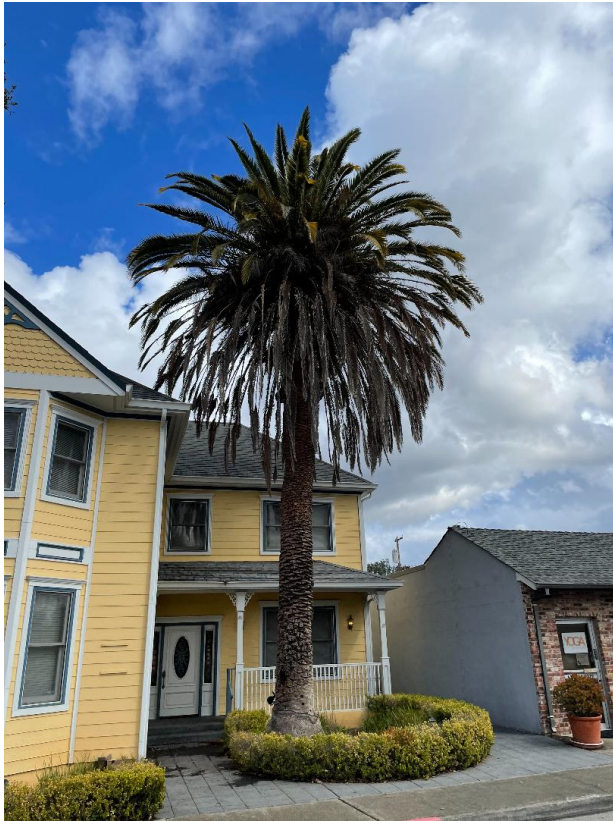
Canary Island palm tree #30 is in good condition.

Showing palm tree #30

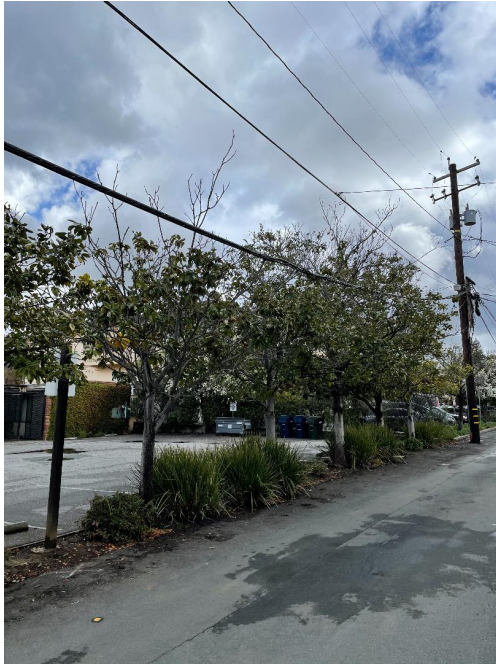
**Showing neighboring magnolias**
