**STUDY SESSION**

**Agenda Item # 1**

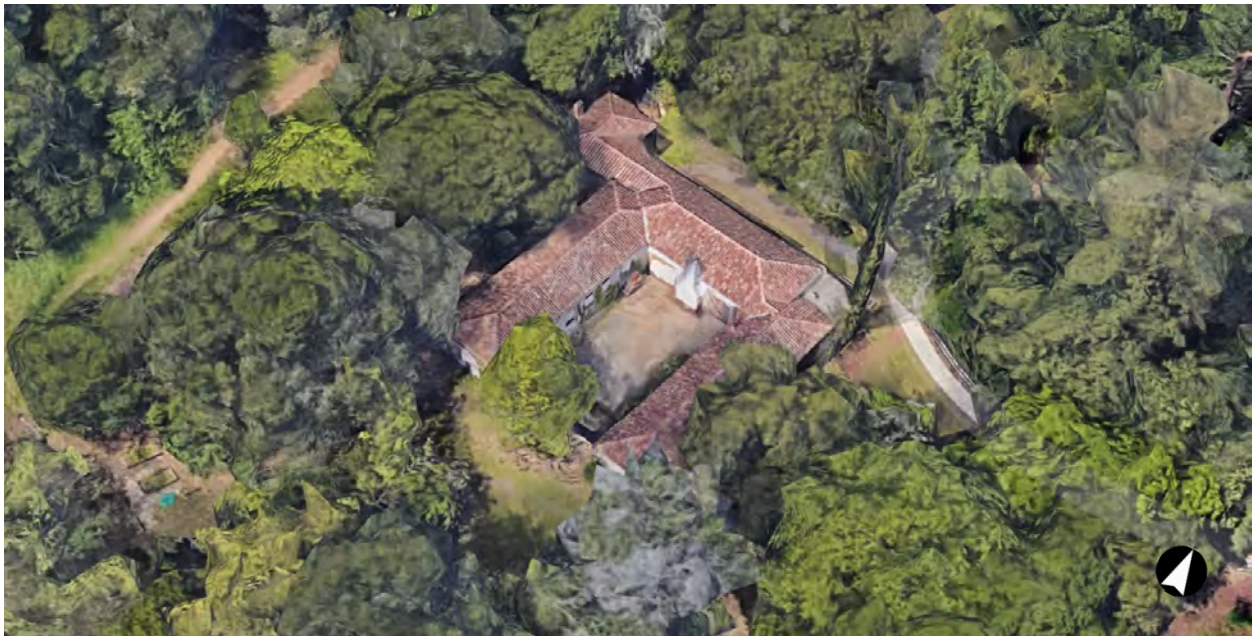
Figure 2: Bird's-eye view of the Halsey House. Source: Google Maps, 2021.

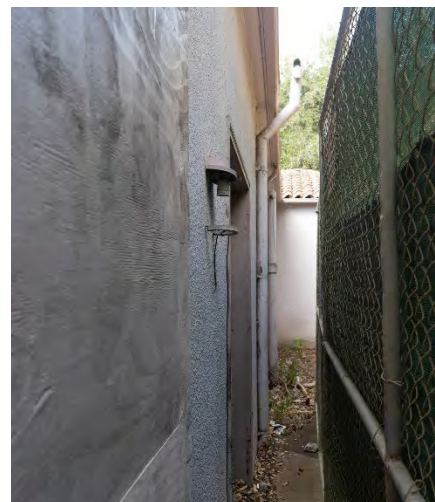
Figure 7: Extant original wall-mounted lamp between French doors at north façade. Looking slightly southwest.

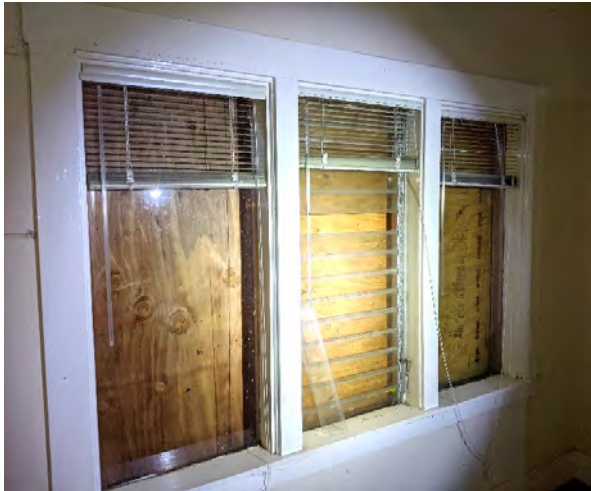
Figure 8: Interior view of jalousie and fixed windows along primary façade. Looking northeast.

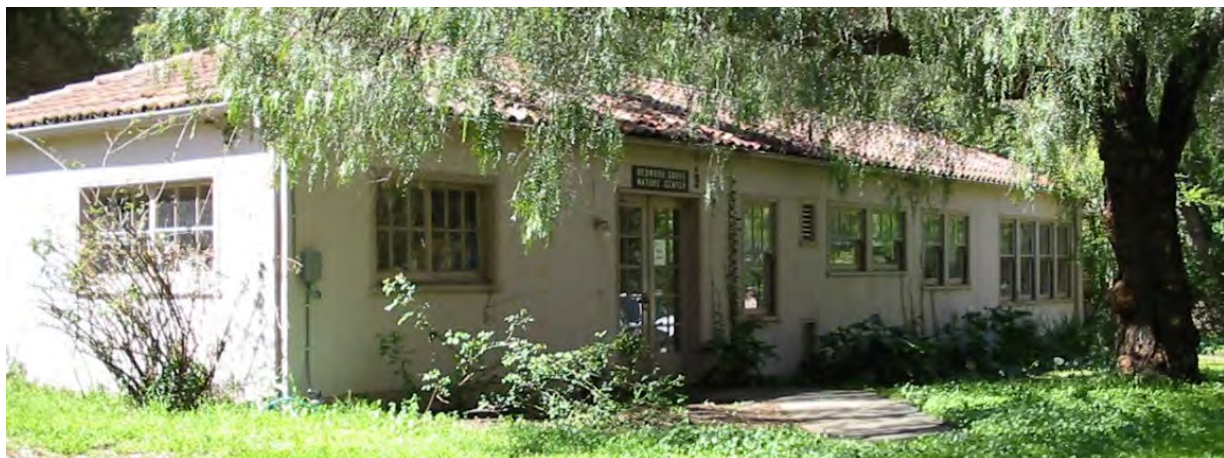
Figure 10: East façade of Halsey House in 2003. Source: City of Los Altos.

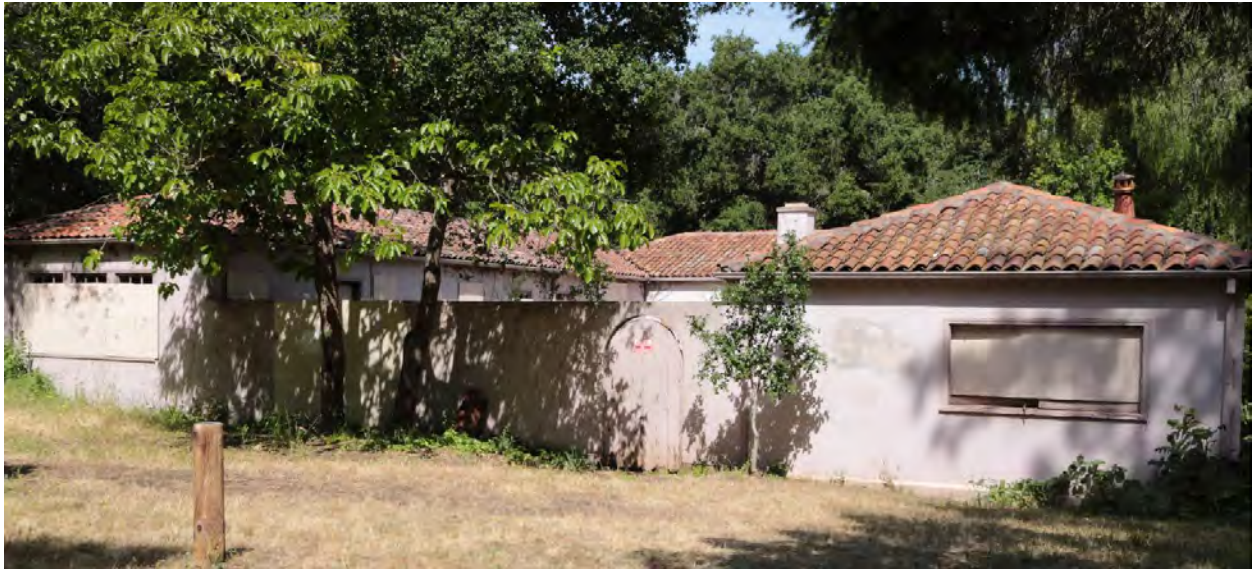
Figure 13: South façade with rear courtyard wall. Looking slightly northwest. Source: HSR by ARG, taken in May 2019.

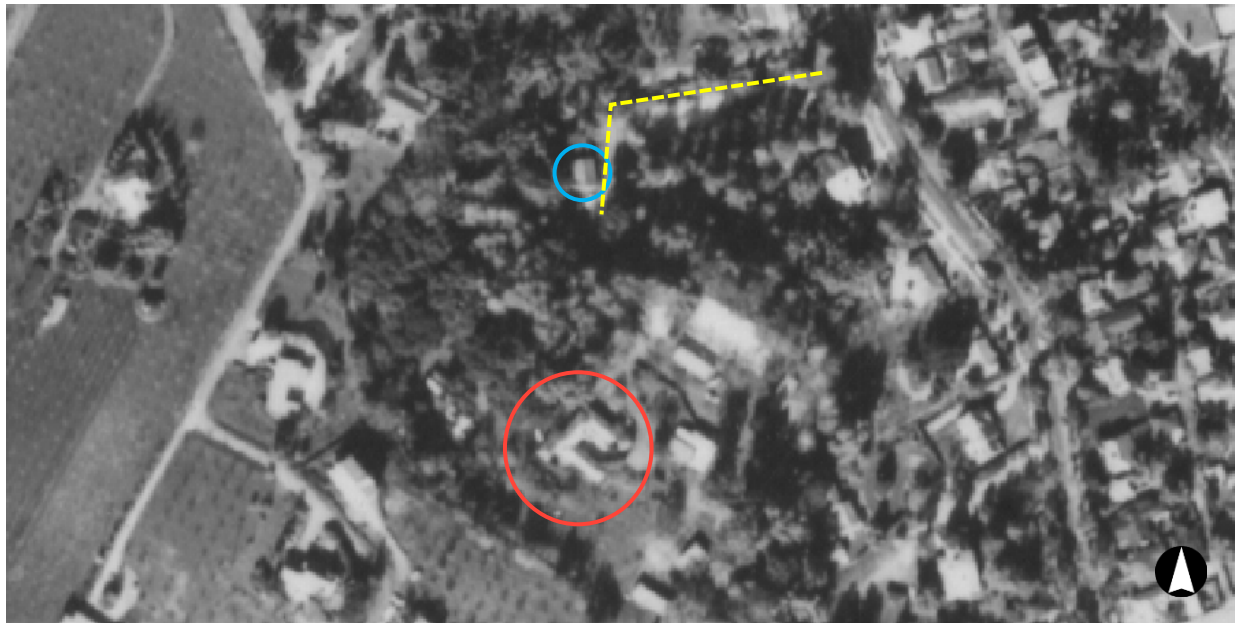
Figure 37: 1963 aerial photograph. Red circle shows location of Halsey House; blue circle shows the location of the extant caretaker's cottage; yellow dashed line shows the access road from University Avenue. Flight: CAS-SCL, Frame: 5-37. Source: UC Santa Barbara, Frame Finder. Edited by Page & Turnbull.

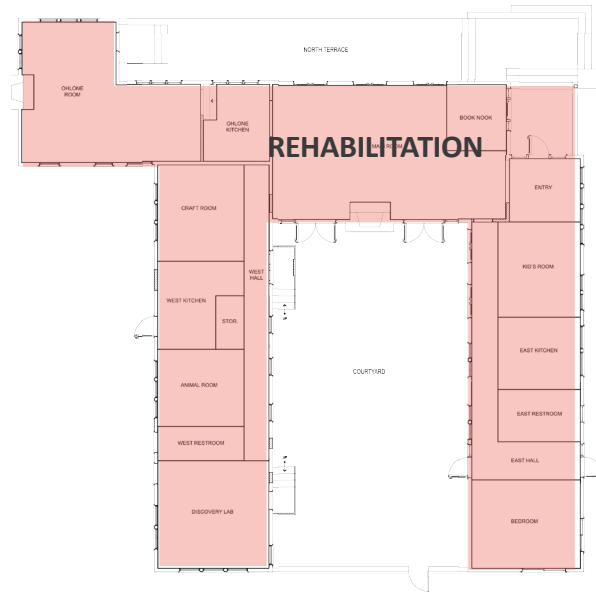
*Building plan showing areas of rehabilitation (red).*

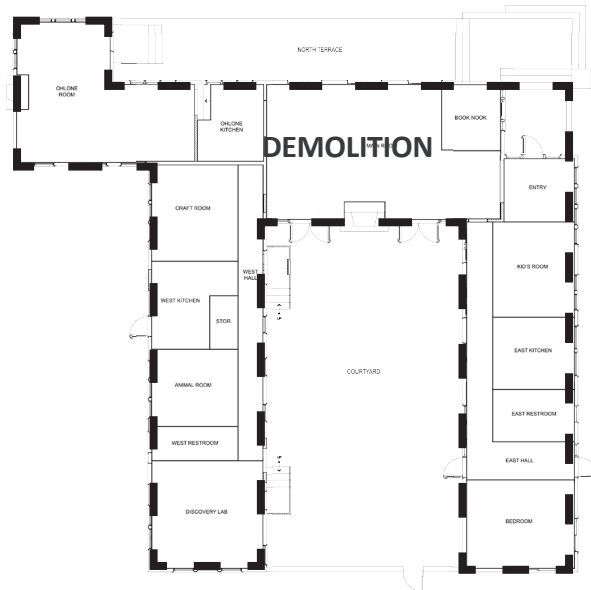
*Building plan showing areas of demolition (dashed).*

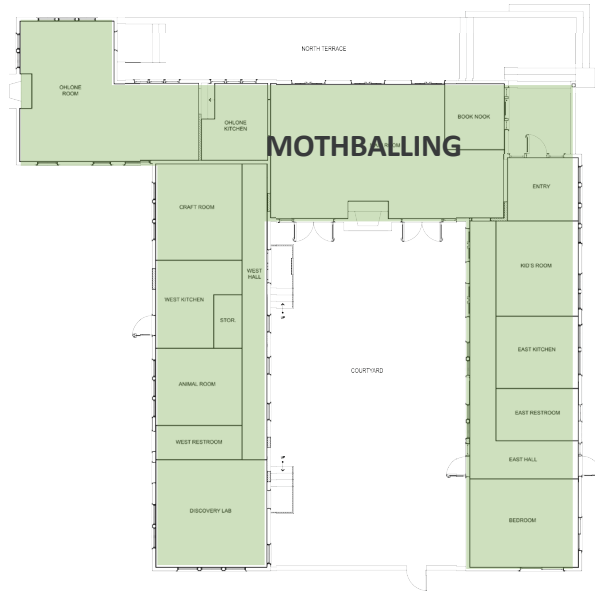
Building plan showing areas of mothballing (green).

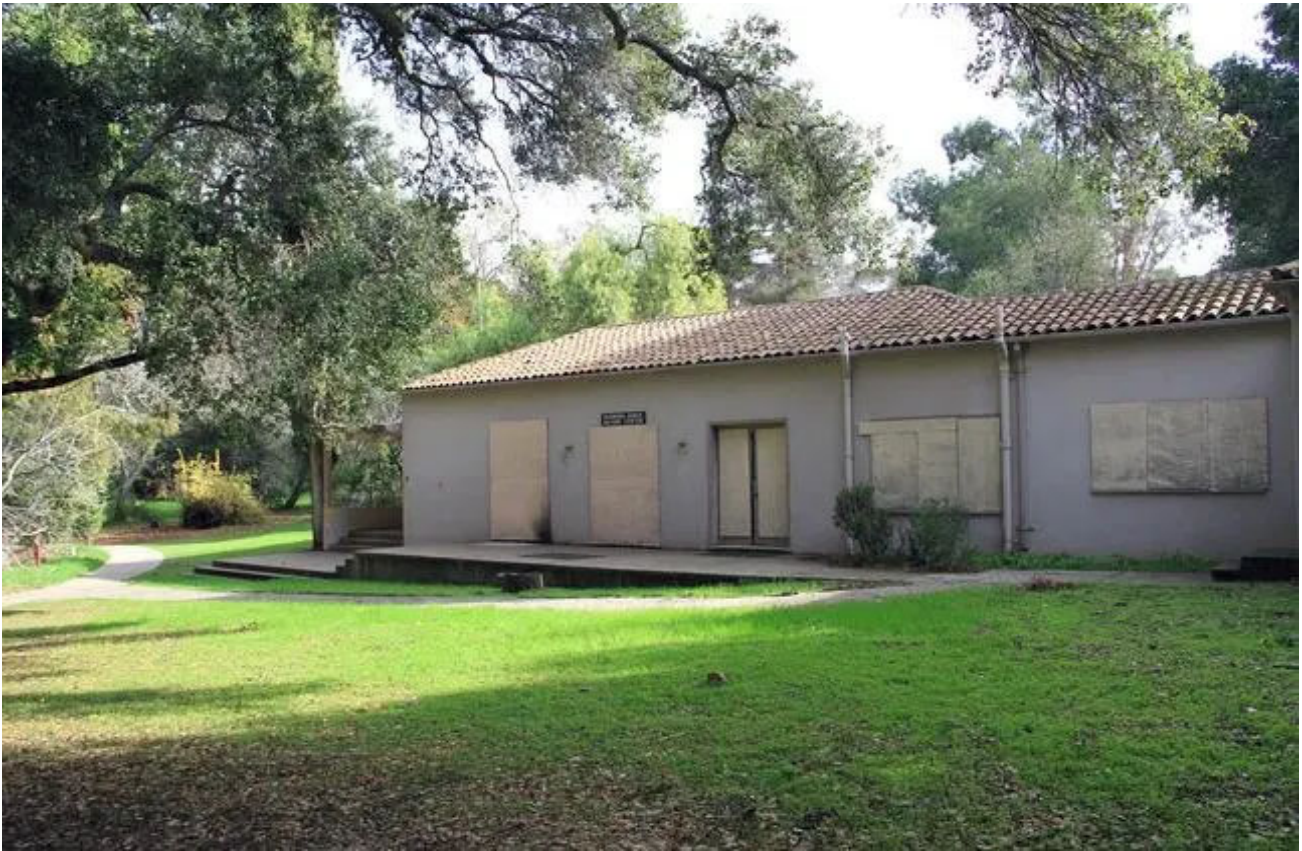
## Appendix A: Cost Estimate

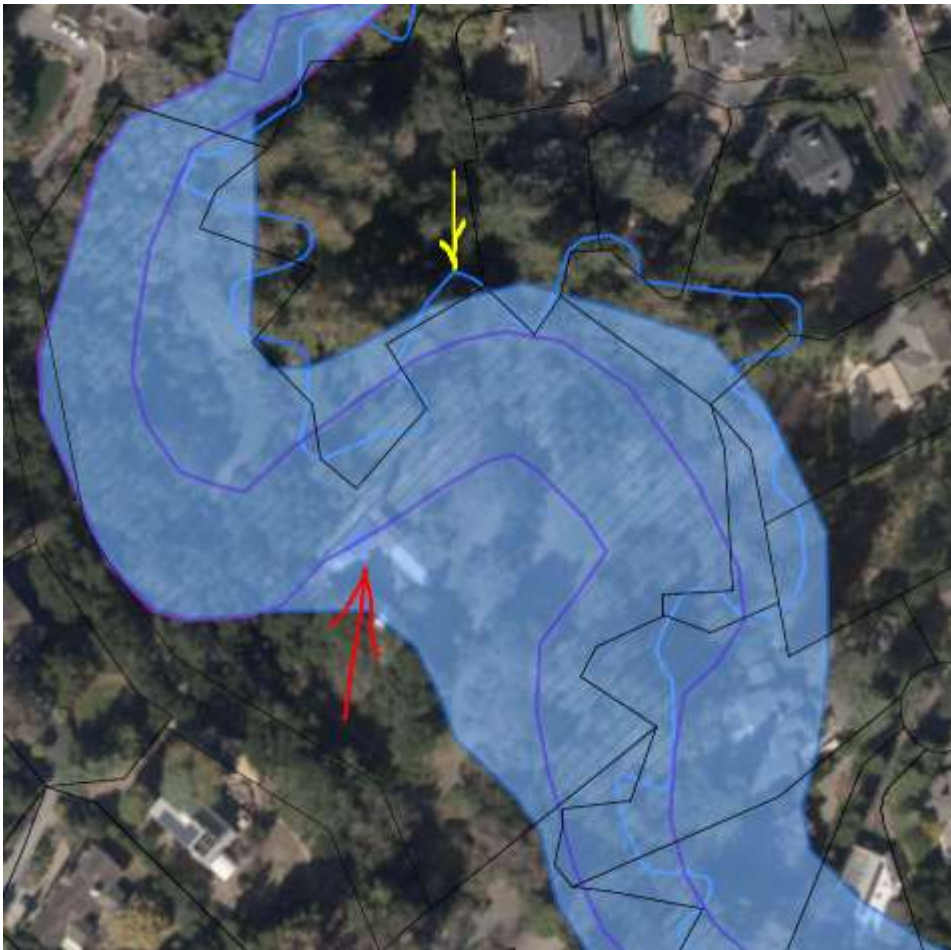
by Valley Water (indicated with the yellow arrow). The red arrow is the location of the Halsey House building. Since the Halsey House encroaches within the Regulatory Floodway and the area designated SFHA AE, regulatory requirements for both of these zones shall apply. Be aware that there are specific regulatory requirements for development within a Regulated Floodway (typically called a “no-rise certification”) in addition to flood resistant construction requirements (e.g. foundation designed to resist flood loads, lowest floors elevated, flood damage-resistant materials, etc) in compliance with California Building Standards Code which are typically applied to development within the AE flood zone.
