**Subject:** Professional Service Agreement for Fremont Avenue Pedestrian Bridge Rehabilitation Project, TS-01055

**REHABILITATION VERSUS REPLACEMENT  
FEASIBILITY STUDY  
FOR  
FREMONT AVENUE PEDESTRIAN BRIDGE OVER  
PERMANENTE CREEK**

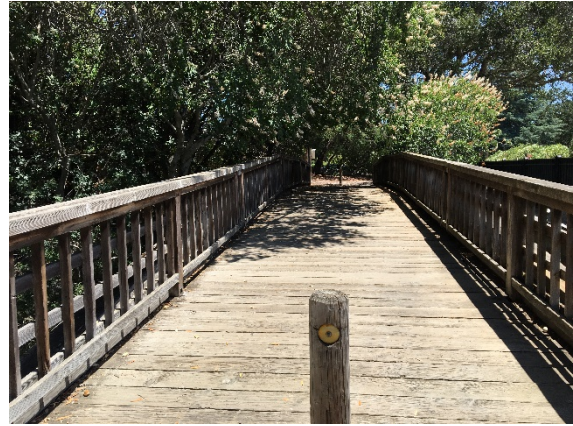
Fremont Avenue is a principle collector urban road within Los Altos, California. The Fremont Avenue Bridge was just replaced and a sidewalk on the north side was omitted given the existing timber pedestrian bridge located just north of the new bridge carries pedestrian and bicycle traffic crossing over Permanente Creek from East to West. The timber pedestrian bridge was constructed in the mid-1970's. The superstructure consists of three spans of timber stringers with timber decking and a curb-to-curb width of 11'. The main span consists of 3'-9" deep glulam beams. The two end spans consist of 6x12 timber stringers. The substructure consists of a single CIDH pile supporting a concrete cap beam which the glulam and timber stringers sit on. The end spans are supported on bin type abutments.

The structure is considered to be in overall good condition, but has isolated areas that need repair. No as-built drawings are available so DHA performed a site inspection of the bridge to identify potential damaged members and to estimate member sizes that were not accessible.

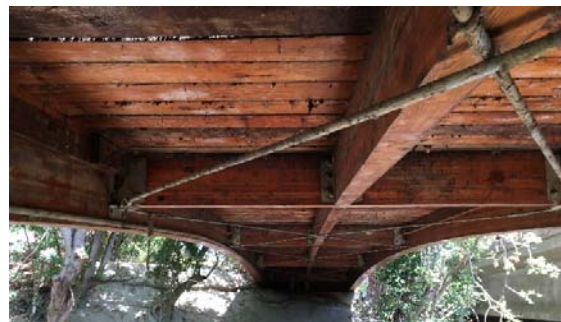
Figure 2 – Deck Underside

2. **Structural Blocking and Cross Bracing Replacement:** For the purposes of the rehabilitation vs. replacement comparison, all of the structural blocking and cross bracing is assumed to be replaced. Figure 2 shows the level of extent of the dry rot that exist in several of the lateral decking supports. It should be noted, however, that many of the cross bracing is in relatively good condition and may not necessarily need to be replaced.

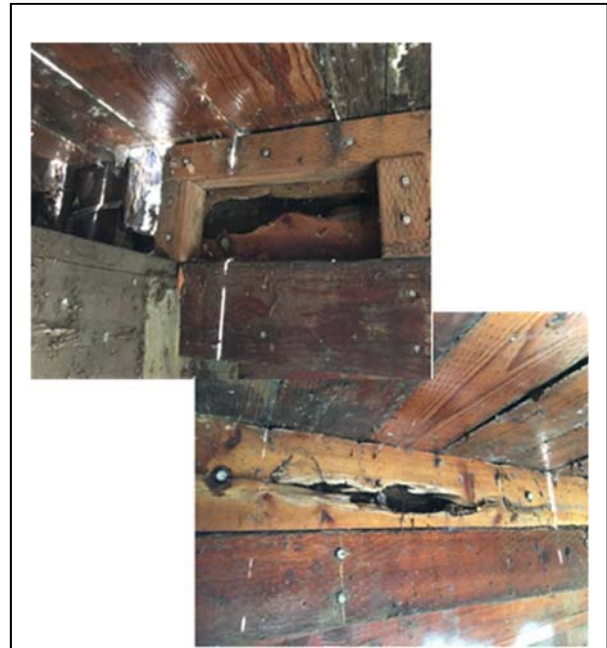
Figure 3 – Structural Blocking Dry Rot

4. **Drainage System:** Based on a visual inspection, much of the water drains along the deck to the south abutment. The water intrusion is causing severe dry rot at some of the railing posts and blocking beneath the structure. The design will need to address drainage in order to prevent this from occurring in the future.

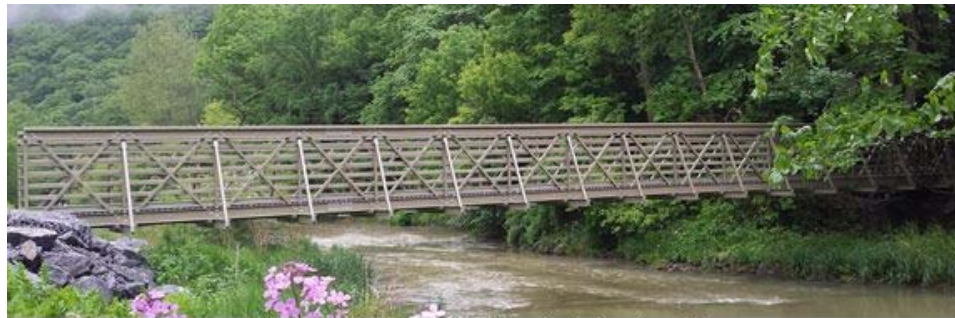
- A. Pre-fabricated fiberglass truss bridge: A new single span fiberglass truss bridge, with pressure treated 3x12 timber decking meeting current AASHTO and Caltrans standards. The fiberglass structure would be able to sufficiently span the creek in a single span, preventing intermediate supports within the creek.

Hiking Trail Bridge – 85' x 4' located in Loysburg, PA

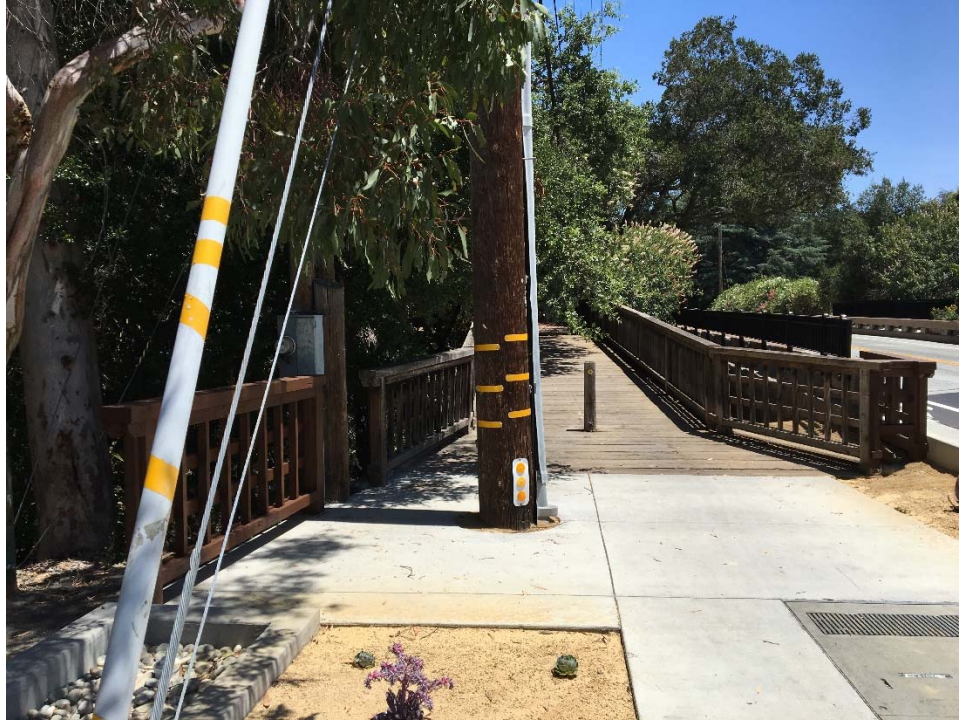
*Figure 1 - Pedestrian Bridge looking east with close proximity to utilities*

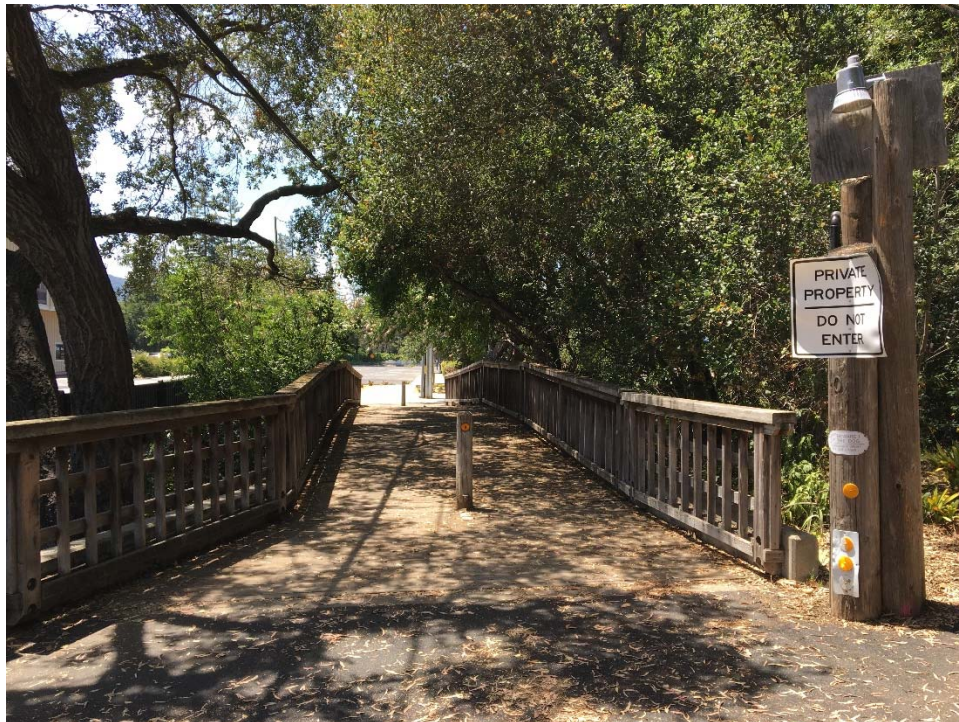
*Figure 2 - Pedestrian Bridge looking west with close proximity to trees and overhead utility*

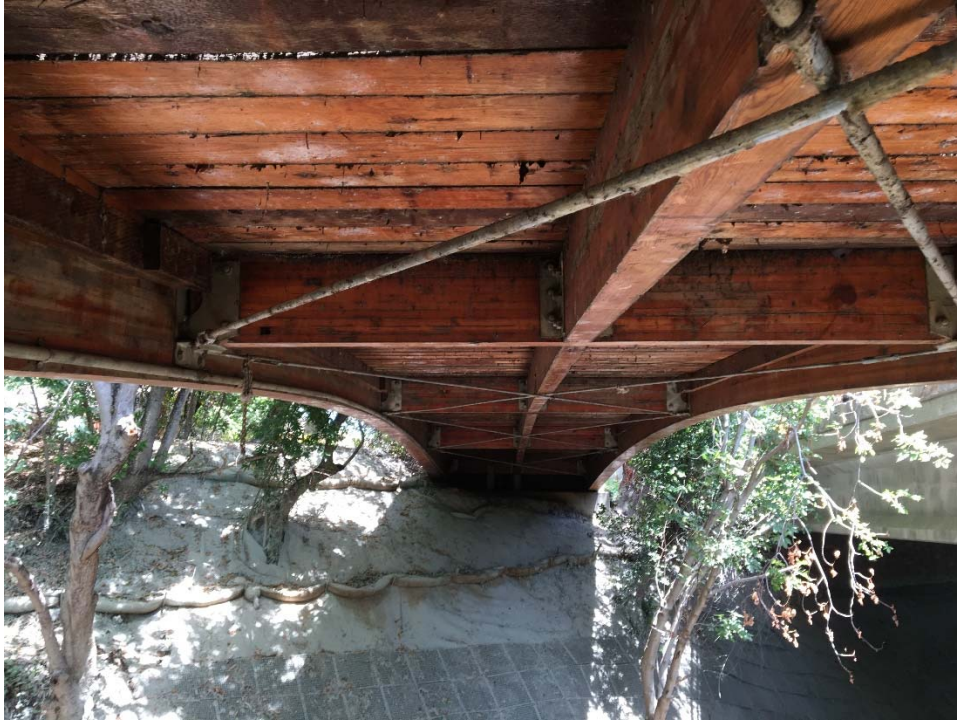
Hardware/Connections/Lateral Supports – The existing metal brackets, connections and lateral supports, see Figure 3 in Appendix D, are all in good condition per DHA's field review on June 1<sup>st</sup>, 2016.

*Figure 3 - Pedestrian Bridge soffit looking east, with bracing and attached utility line*

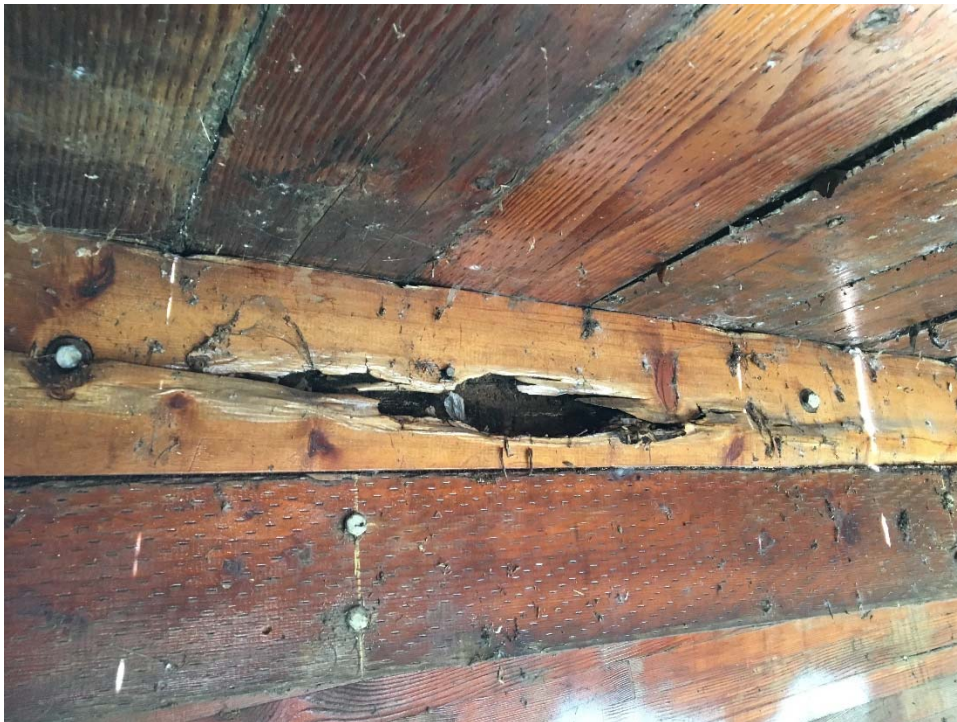
Blocking – The existing blocking is in various states of deterioration, with the tapered sections on each end showing significant deterioration, see Figures 4 and 5 in Appendix D. Due to the various stages of deterioration and how significantly the tapered blocking is deteriorated, DHA recommends replacing all of the existing blocking. It may be possible to salvage some of the blocking from the center of the bridge, once the members can be inspected with the deck removed.

*Figure 4 - Pedestrian Bridge blocking with severe deterioration*

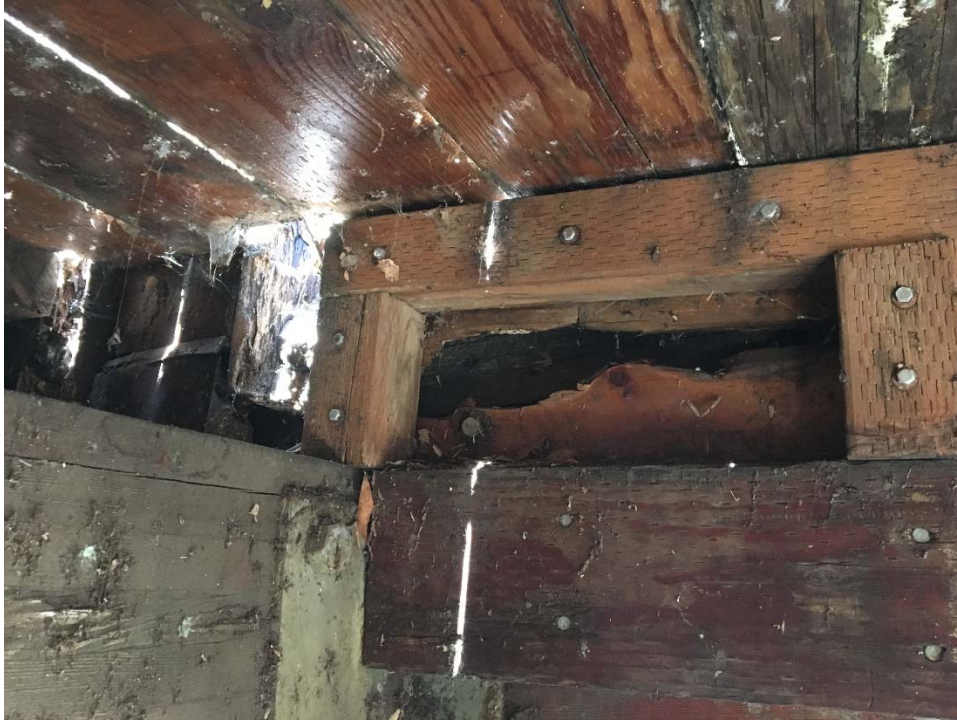
*Figure 5 - Soffit of Pedestrian Bridge with blocking and handrail post deterioration and repaired section*

Deck Drainage – The existing structure drains down the length of the handrail posts, which is causing significant deterioration at the bottom of the posts. DHA recommends implementing a drainage system to carry water runoff, off of the bridge to protect the handrail posts and glulam members from future deterioration.

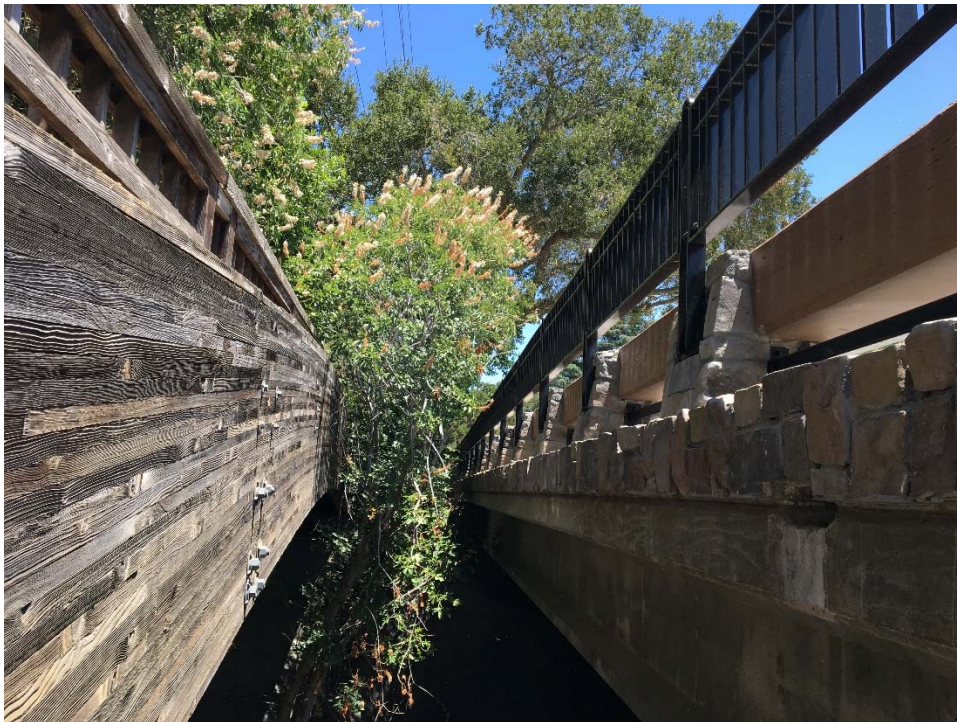
*Figure 6 - South side of Pedestrian Bridge with close proximity to vehicular bridge*

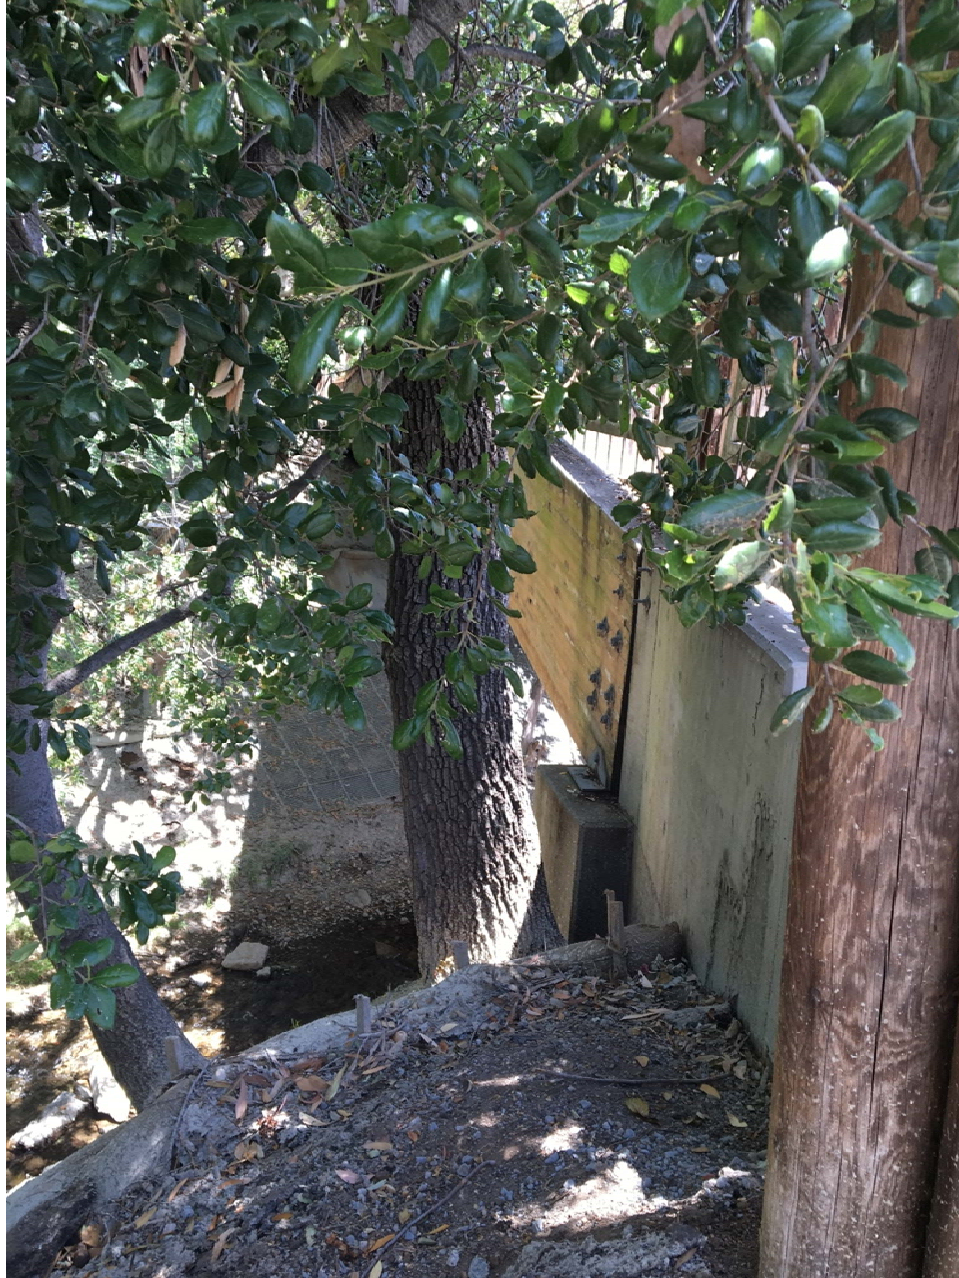
*Figure 7 - Northwest corner of Pedestrian Bridge with close proximity to existing trees and utility pole*

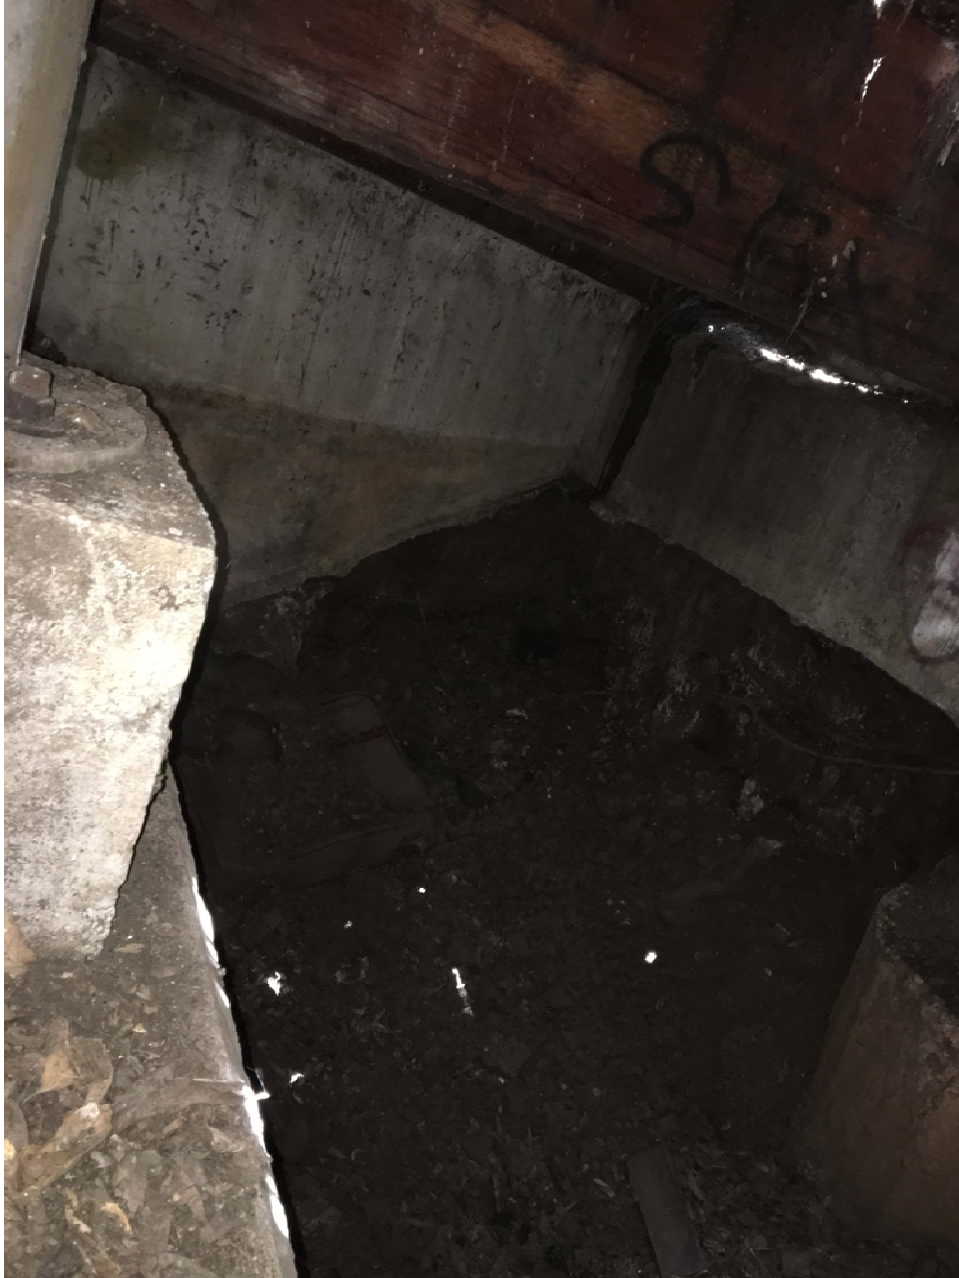
Backfill – There is a large amount of scour at the west abutment which has resulted in minor settling, see Figure 8 in Appendix D. DHA recommends backfilling the abutment with rock during the bridge deck replacement to prevent future scour and settlement.

5. **Backfill for Scour:** Both abutments are similar to bin type abutments which have a front wall and a back wall. In this case, the front wall is protecting the abutment backwall from erosion and scour until the water in the creek is high enough to overtop the front wall. This has occurred and the dirt area between the wall and back abutment on the south abutment is scouring. For rehabilitation, it is recommended to fill this void with rock to prevent future scour.

*Figure 8 - Pedestrian Bridge bin abutment with scour*
